# Manhole Inspection Summary

Manhole # S39K\_\_026MH

Insp Date: **2/17/09 11:24 AM**

**Location** Address: **721 eastern av**

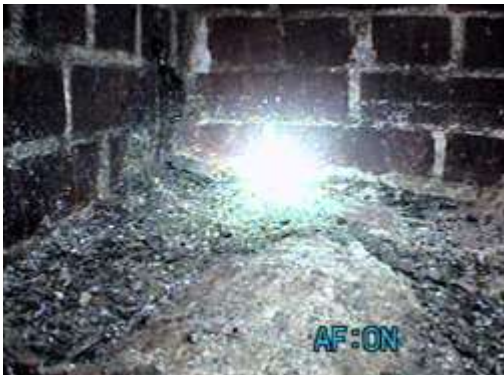
Defect 2

Condition: ☐ Sound ☐ Cracked ☐ Root Intrusion ☐ Deteriorated ☐ Leaks ☒ Debris

bench debris

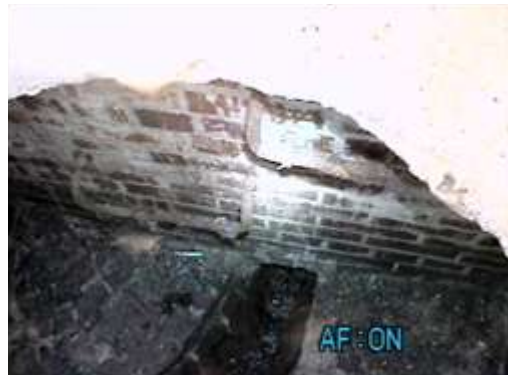
Defect 1

Count: **2** Missing: **0** ☒ Corroded

corr steps

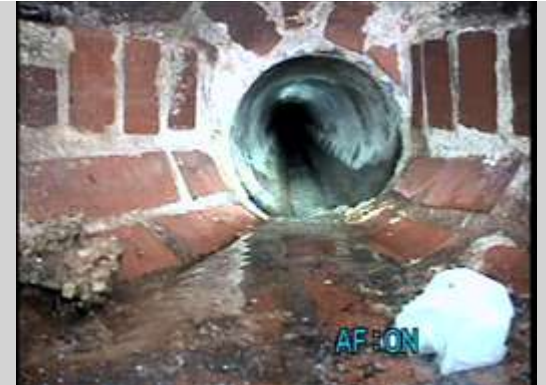
12 O'Clock Outflow

8 in. Circular Gravity Sewer  
Pipe Out @ 12 O'Clock

Invert Depth: **5.96** (ft.) Flow Characteristics: **Slow**

Infiltration: **None** Pipe Seal Cond: **Unknown**

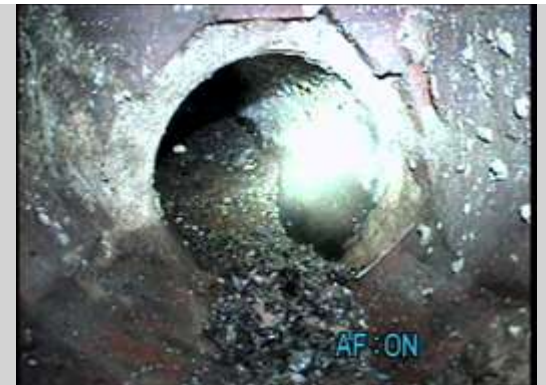
3 O'Clock Inflow

8 in. Circular Gravity Sewer  
Pipe In @ 3 O'Clock

Invert Depth: **5.88** (ft.) Flow Characteristics: **None**

Infiltration: **None** Pipe Seal Cond: **Unknown**

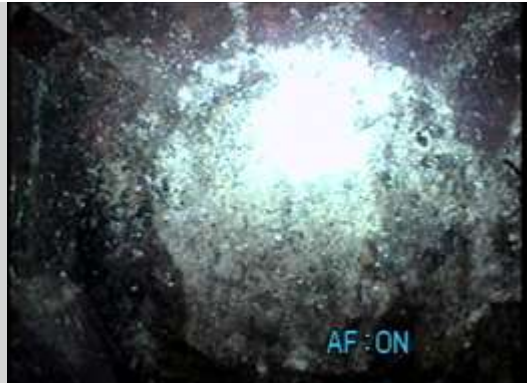
6 O'Clock Inflow

sealed off

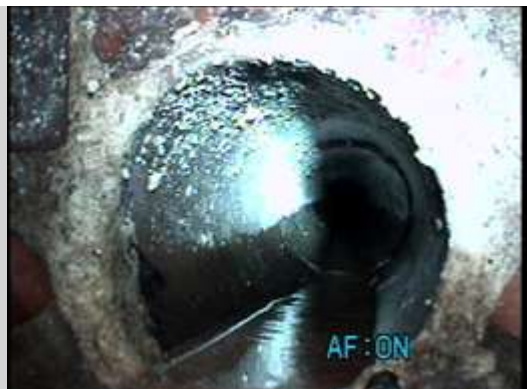
9 O'Clock Inflow

6 in. Circular Gravity Sewer

Invert Depth: **5.88** (ft.) Flow Characteristics: **Slow**

Infiltration: **None**
